**Flood Control Project Maintenance
Levee Inspections**

Maintenance Issue Types Only, Levee Inspection Report By Mile - Spring 2017

Sacramento Maintenance Yard Willow Slough Bypass

Waterway	Bank	Unit Miles	Inspection Start/End	Inspector
Unit No. 01 Willow Slough Bypass or North Levee	Left	5.05	04/18/2017 04/18/2017	Zach Jojola

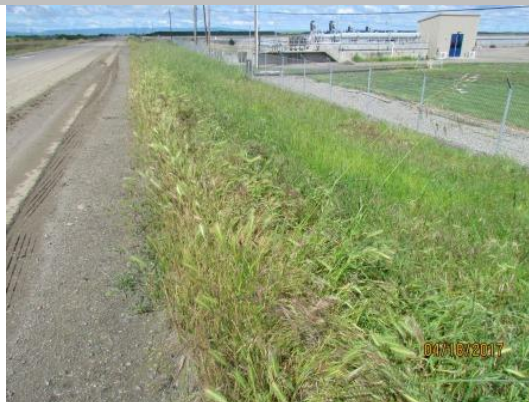
Photo 1 of 1 : SP_2017_ST0012_295_19_20170419_00018.jpg

LM Start	0.09	Rating **	U	Issue No.	19
LM End	3.51	Issue Type +	Ma	Location *	LS
Category	Earthen Levee			GPS Latitude/Longitude	
				Start	End
Item	Vegetation			38.590764 °	38.590766 °
				-121.666949 °	-121.730034 °
DWR ID	DWR_ST0012_01_s_2017_19				
Comment Code					
V1 : Control annual grass and weeds on the levee slopes and easements.					
Inspector Comment

Tall grass on landside levee slope, blocking visibility. Spring 2017.

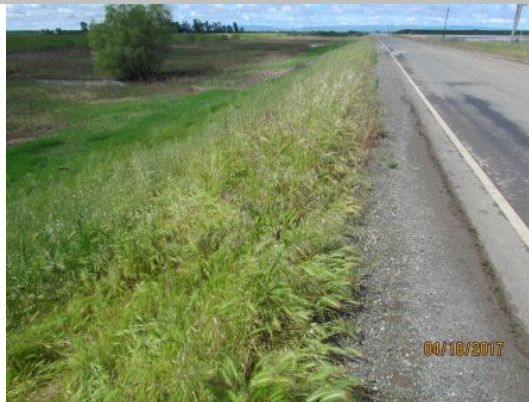
Photo 1 of 1 : SP_2017_ST0012_295_20_20170419_00019.jpg

LM Start	0.56	Rating **	U	Issue No.	20
LM End	3.51	Issue Type +	Ma	Location *	WS
Category	Earthen Levee			GPS Latitude/Longitude	
				Start	End
Item	Vegetation			38.590585 °	38.590767 °
				-121.675592 °	-121.730035 °
DWR ID	DWR_ST0012_01_s_2017_20				
Comment Code					
V1 : Control annual grass and weeds on the levee slopes and easements.					
Inspector Comment

Tall grass on waterside levee slope, blocking visibility. Spring 2017.

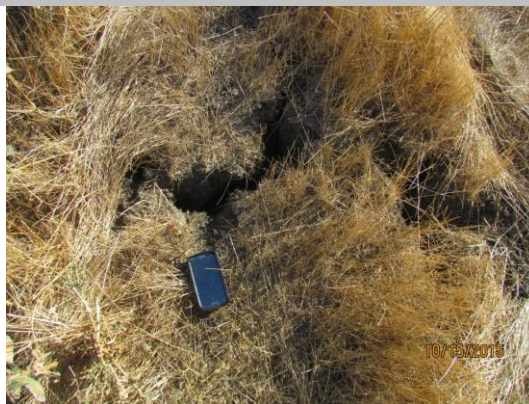
Photo 1 of 3 : SP_2017_ST0012_295_16_20170320_00014.jpg

LM Start	0.90	Rating **	A/W	Issue No.	16
LM End	0.90	Issue Type +	Ma	Location *	LS
Category	Earthen Levee			GPS Latitude/Longitude	
				Start	End
Item	Cracking			38.590456 °	38.590456 °
				-121.681952 °	-121.681952 °
DWR ID	DWR_ST0012_01_f_2015_16				
Comment Code					
CR1 : Monitor and have inspected by geotechnical engineer.					
Inspector Comment

View of the dessication cracking on the landward side of the levee. Fall 2015.

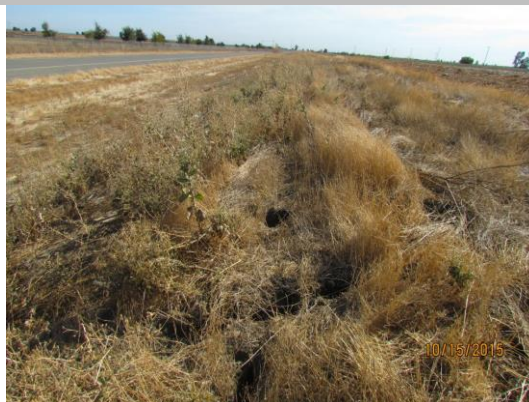
Photo 2 of 3 : SP_2017_ST0012_295_16_20170320_00015.jpg

LM Start	0.90	Rating **	A/W	Issue No.	16 (cont)
LM End	0.90	Issue Type +	Ma	Location *	LS

Perspective view of the crack looking downstream. Fall 2015.

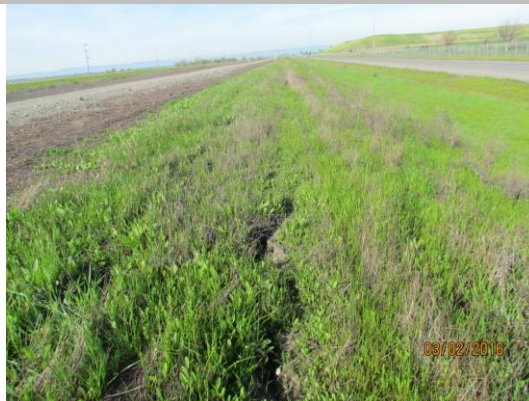
Photo 3 of 3 : SP_2017_ST0012_295_16_20170320_00016.jpg

LM Start	0.90	Rating **	A/W	Issue No.	16 (cont)	
LM End	0.90	Issue Type +	Ma	Location *	LS	
Category	Earthen Levee			GPS Latitude/Longitude		
				Start		End
Item	Cracking			38.590456 °		38.590456 °
				-121.681952 °		-121.681952 °
DWR ID	DWR_ST0012_01_f_2015_16					
Comment Code						
CR1 : Monitor and have inspected by geotechnical engineer.						
Inspector Comment

View of the crack on the landward side of the levee looking upstream.
Spring 2016.

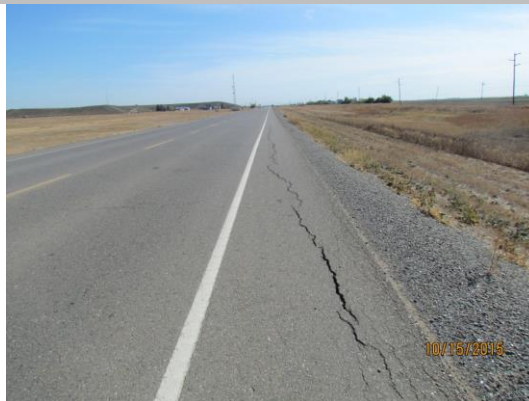
Photo 1 of 3 : SP_2017_ST0012_295_15_20170320_00011.jpg

LM Start	1.86	Rating **	A/W	Issue No.	15
LM End	1.88	Issue Type +	Ma	Location *	CR
Category	Earthen Levee			GPS Latitude/Longitude	
				Start	End
Item	Cracking			38.590378 °	38.590379 °
				-121.699630 °	-121.699920 °
DWR ID	DWR_ST0012_01_f_2015_15				
Comment Code					
CR1 : Monitor and have inspected by geotechnical engineer.					
Inspector Comment					
Cracks starting to form on the waterward slope.

Perspective view of the crack on the crown of the levee looking downstream. Fall 2015.

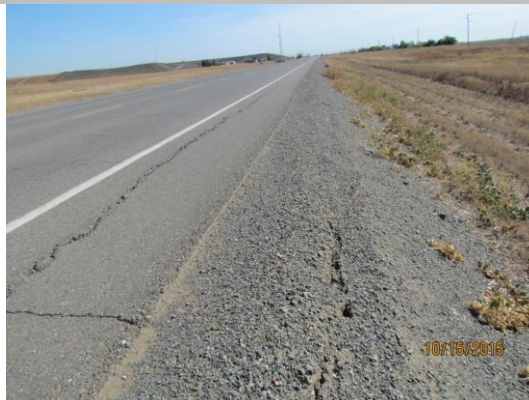
Photo 2 of 3 : SP_2017_ST0012_295_15_20170320_00012.jpg

LM Start	1.86	Rating **	A/W	Issue No.	15 (cont)
LM End	1.88	Issue Type +	Ma	Location *	CR

Cracks are starting to form on the waterward slope of the levee looking downstream. Fall 2015.

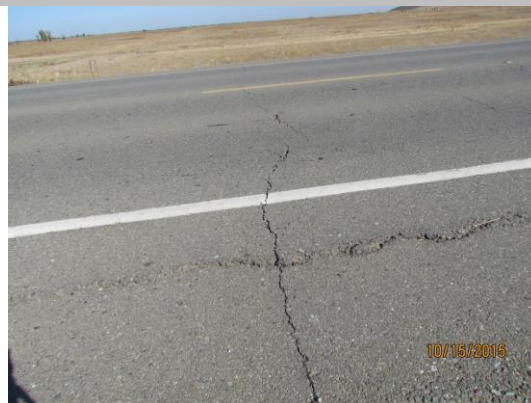
Photo 3 of 3 : SP_2017_ST0012_295_15_20170320_00013.jpg

LM Start	1.86	Rating **	A/W	Issue No.	15 (cont)
LM End	1.88	Issue Type +	Ma	Location *	CR
Category	Earthen Levee			GPS Latitude/Longitude	
				Start	End
Item	Cracking			38.590378 °	38.590379 °
				-121.699630 °	-121.699920 °
DWR ID	DWR_ST0012_01_f_ 2015_15				
Comment Code					
CR1 : Monitor and have inspected by geotechnical engineer.					
Inspector Comment					
Cracks starting to form on the waterward slope.

There is another crack perpendicular to the crack on the levee crown.
Fall 2015.

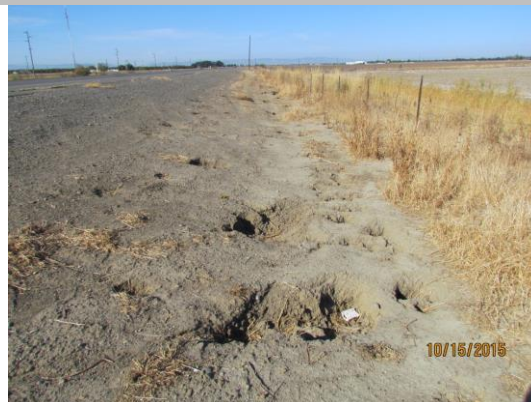
Photo 1 of 1 : SP_2017_ST0012_295_10_20170320_00005.jpg

LM Start	2.93	Rating **	M	Issue No.	10
LM End	3.00	Issue Type +	Ma	Location *	LS
Category	Earthen Levee			GPS Latitude/Longitude	
				Start	End
Item	Erosion / Bank Caving			38.590572 °	38.590653 °
				-121.719349 °	-121.720714 °
DWR ID	DWR_ST0012_01_s_ 2015_10				
Comment Code					
E2 : Schedule repair of erosion site prior to the next inspection.					
Inspector Comment					
Area is known to erode and may be because of the material of the levee.

View of the erosion on the landward side of the levee looking upstream.
Fall 2015.

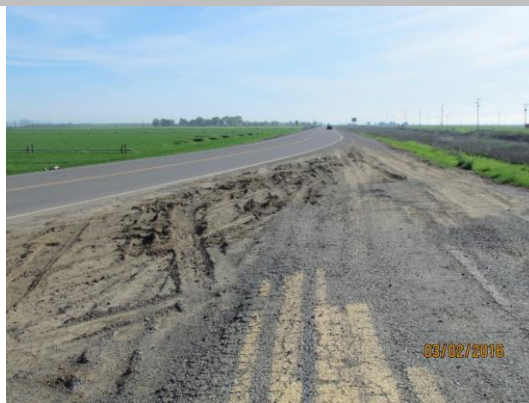
Photo 1 of 1 : SP_2017_ST0012_295_13_20170320_00009.jpg

LM Start	3.36	Rating **	M	Issue No.	13
LM End	3.36	Issue Type +	Ma	Location *	LS
Category	Earthen Levee			GPS Latitude/Longitude	
				Start	End
Item	Crown Surface / Depressions / Rutting			38.590620 °	38.590620 °
				-121.727385 °	-121.727385 °
DWR ID	DWR_ST0012_01_s_2016_13				
Comment Code					
C2 : Repair depressions or ruts in the crown or slope.					
Inspector Comment

View of the ruts created by vehicles on the crown of the levee looking downstream. Spring 2016.

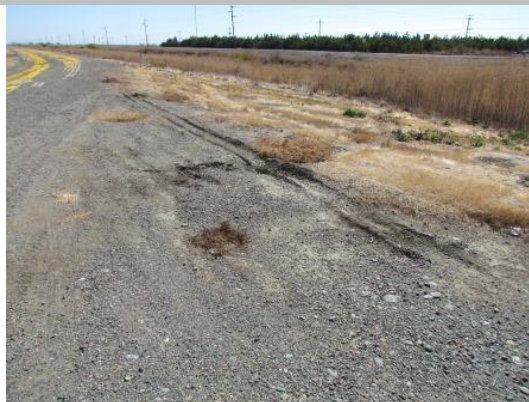
Photo 1 of 1 : SP_2017_ST0012_295_3_20170320_00001.jpg

LM Start	3.50	Rating **	M	Issue No.	3
LM End	3.50	Issue Type +	Ma	Location *	CR
Category	Earthen Levee			GPS Latitude/Longitude	
				Start	End
Item	Crown Surface / Depressions / Rutting			38.590731 °	38.590731 °
				-121.729906 °	-121.729906 °
DWR ID	DWR_ST0012_01_f_2016_3				
Comment Code					
C2 : Repair depressions or ruts in the crown or slope.					
Inspector Comment

Ruts on levee crown due to vehicular activity. Fall 2016.

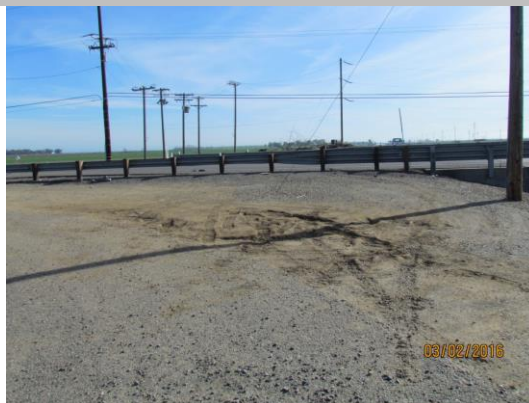
Photo 1 of 1 : SP_2017_ST0012_295_18_20170320_00017.jpg

LM Start	3.54	Rating **	M	Issue No.	18
LM End	3.54	Issue Type +	Ma	Location *	CR
Category	Earthen Levee			GPS Latitude/Longitude	
				Start	End
Item	Crown Surface / Depressions / Rutting			38.590685 °	38.590685 °
				-121.730657 °	-121.730657 °
DWR ID	DWR_ST0012_01_s_2016_18				
Comment Code					
C2 : Repair depressions or ruts in the crown or slope.					
Inspector Comment

View of the ruts caused by vehicles on the crown of the levee looking downstream. Spring 2016.

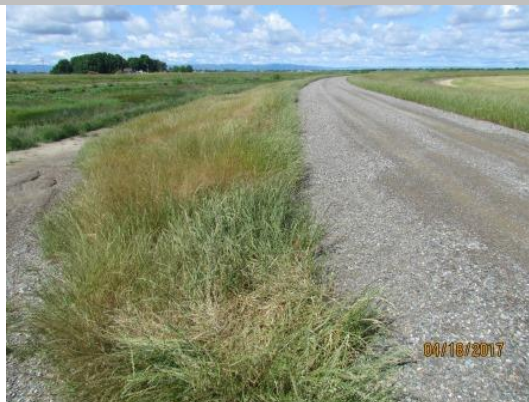
Photo 1 of 1 : SP_2017_ST0012_295_21_20170419_00020.jpg

LM Start	3.55	Rating **	U	Issue No.	21
LM End	5.04	Issue Type +	Ma	Location *	WS
Category	Earthen Levee			GPS Latitude/Longitude	
				Start	End
Item	Vegetation			38.590704 °	38.599981 °
				-121.730787 °	-121.753014 °
DWR ID	DWR_ST0012_01_s_2017_21				
Comment Code					
V1 : Control annual grass and weeds on the levee slopes and easements.					
Inspector Comment

Tall grass on waterside levee slope, blocking visibility. Spring 2017.

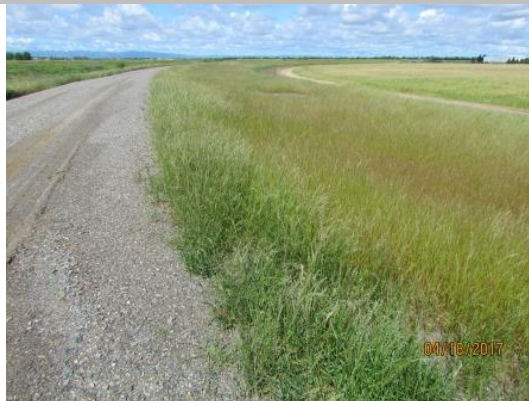
Photo 1 of 1 : SP_2017_ST0012_295_22_20170419_00021.jpg

Tall grass on landside levee slope, blocking visibility. Spring 2017.

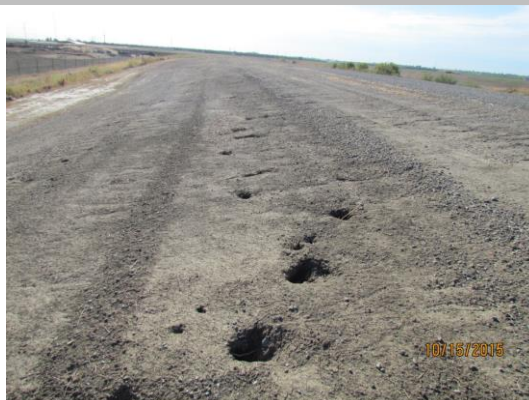
Photo 1 of 2 : SP_2017_ST0012_295_12_20170320_00007.jpg

LM Start	3.90	Rating **	A/W	Issue No.	12
LM End	3.90	Issue Type +	Ma	Location *	LS
Category	Earthen Levee			GPS Latitude/Longitude	
				Start	End
Item	Cracking			38.594149 °	38.594149 °
				-121.735254 °	-121.735254 °
DWR ID	DWR_ST0012_01_f_2015_12				
Comment Code					
CR1 : Monitor and have inspected by geotechnical engineer.					
Inspector Comment					
The sinkholes are caused by the material of the levee and runoffs. These are not rodent holes.

View of the sinkholes on the landward side of the levee looking downstream. Fall 2015.

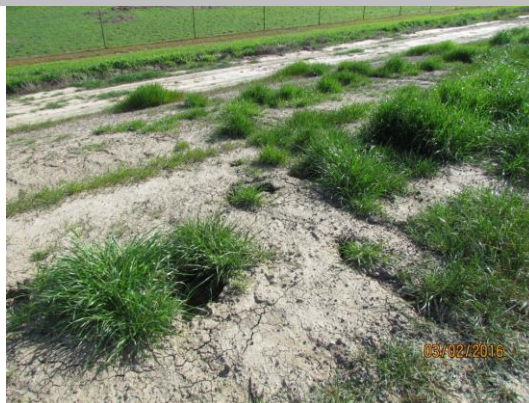
Photo 2 of 2 : SP_2017_ST0012_295_12_20170320_00008.jpg

LM Start	3.90	Rating **	A/W	Issue No.	12 (cont)	
LM End	3.90	Issue Type +	Ma	Location *	LS	
Category	Earthen Levee			GPS Latitude/Longitude		
				Start		End
Item	Cracking			38.594149 °		38.594149 °
				-121.735254 °		-121.735254 °
DWR ID	DWR_ST0012_01_f_2015_12					
Comment Code						
CR1 : Monitor and have inspected by geotechnical engineer.						
Inspector Comment						
The sinkholes are caused by the material of the levee and runoffs. These are not rodent holes.

View of the sinkholes on the landward side of the levee. Sinkholes are caused due to material of the levee and runoffs. Spring 2016.

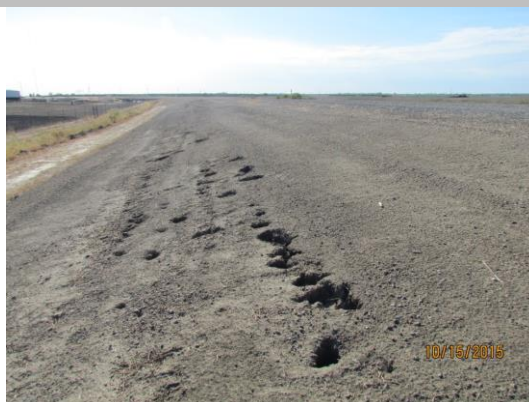
Photo 1 of 1 : SP_2017_ST0012_295_11_20170320_00006.jpg

LM Start	3.94	Rating **	A/W	Issue No.	11
LM End	3.94	Issue Type +	Ma	Location *	LS
Category	Earthen Levee			GPS Latitude/Longitude	
				Start	End
Item	Cracking			38.594645 °	38.594645 °
				-121.735712 °	-121.735712 °
DWR ID	DWR_ST0012_01_f_2015_11				
Comment Code					
CR1 : Monitor and have inspected by geotechnical engineer.					
Inspector Comment					
The sinkholes are caused by the material of the levee and runoffs. These are not rodent holes.

View of the sinkholes on the landward side of the levee looking downstream. Fall 2015.

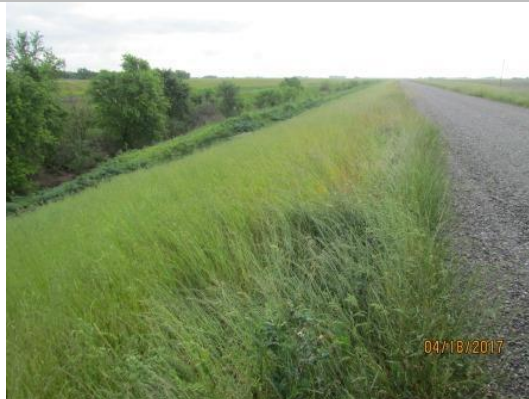
Photo 1 of 1 : SP_2017_ST0012_296_12_20170419_00037.jpg

Tall grass on waterside levee slope, blocking visibility. Spring 2017.

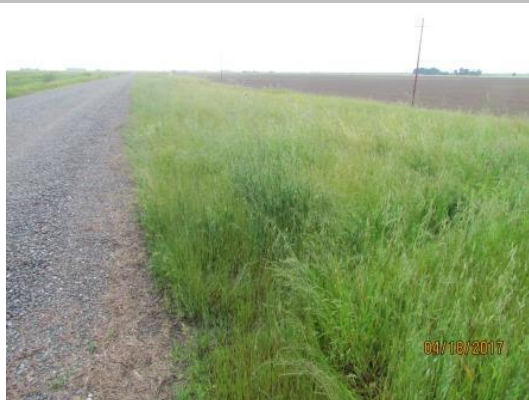
Photo 1 of 1 : SP_2017_ST0012_296_6_20170419_00038.jpg

LM Start	0.03	Rating **	U	Issue No.	6
LM End	0.69	Issue Type +	Ma	Location *	LS
Category	Earthen Levee			GPS Latitude/Longitude	
				Start	End
Item	Vegetation			38.599035 °	38.598985 °
				-121.753915 °	-121.741673 °
DWR ID	DWR_ST0012_02_s_2017_6				
Comment Code					
V1 : Control annual grass and weeds on the levee slopes and easements.					
Inspector Comment

Tall grass on landside levee slope, blocking visibility. Spring 2017.

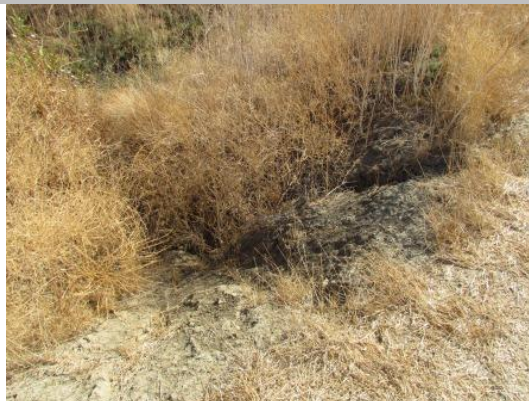
Photo 1 of 1 : SP_2017_ST0012_296_23_20170320_00029.jpg

View of an erosion site around UCIP pipe FSID 13725 on waterward side of the levee. Fall 2016.

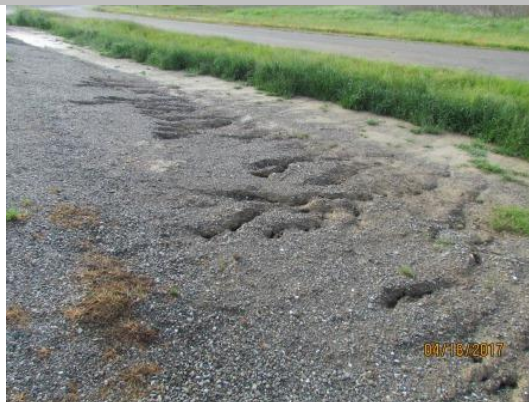
Photo 1 of 1 : SP_2017_ST0012_296_21_20170419_00039.jpg

LM Start	1.54	Rating **	M	Issue No.	21	
LM End	1.54	Issue Type +	Ma	Location *	LS	
Category	Earthen Levee			GPS Latitude/Longitude		
				Start		End
Item	Erosion / Bank Caving			38.590108 °		38.590108 °
				-121.731254 °		-121.731254 °
DWR ID	DWR_ST0012_02_s_2017_21					
Comment Code						
E2 : Schedule repair of erosion site prior to the next inspection.						
Inspector Comment						
Rills on landside levee slope.

View of rills on landside levee slope. Spring 2017.

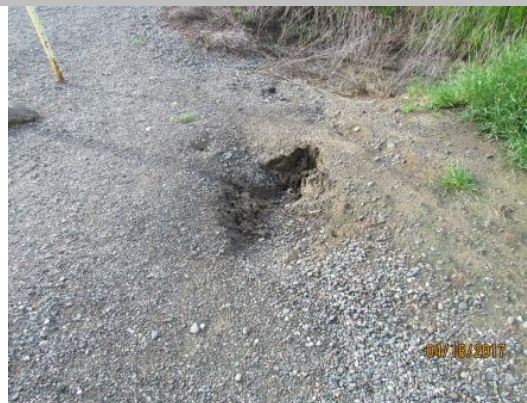
Photo 1 of 1 : SP_2017_ST0012_296_29_20170419_00040.jpg

LM Start	1.57	Rating **	M	Issue No.	29
LM End	1.57	Issue Type +	Ma	Location *	LS
Category	Earthen Levee			GPS Latitude/Longitude	
				Start	End
Item	Slope Stability			38.590064 °	38.590064 °
				-121.730723 °	-121.730723 °
DWR ID	DWR_ST0012_02_s_2017_29				
Comment Code					
S3 : Repair the levee slope damaged by vehicle traffic and prevent access where possible.					
Inspector Comment					
Tire damage on landside levee slope.

View of tire damage on landside levee slope. Spring 2017.

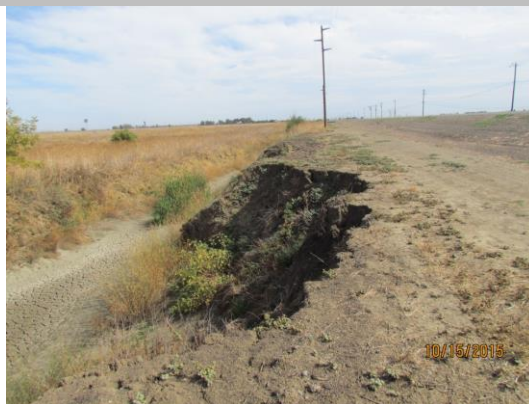
Photo 1 of 1 : SP_2017_ST0012_296_8_20170320_00007.jpg

LM Start	1.77	Rating **	M	Issue No.	8
LM End	1.77	Issue Type +	Ma	Location *	WS
Category	Earthen Levee			GPS Latitude/Longitude	
				Start	End
Item	Erosion / Bank Caving			38.589966 °	38.589966 °
				-121.727072 °	-121.727072 °
DWR ID	DWR_ST0012_02_s_2012_8				
Comment Code					
E2 : Schedule repair of erosion site prior to the next inspection.					
Inspector Comment

View of the erosion on the edge of the channel looking downstream. Fall 2015.

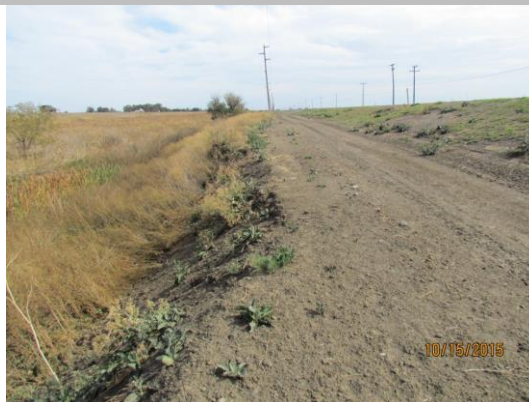
Photo 1 of 2 : SP_2017_ST0012_296_5_20170320_00003.jpg

LM Start	2.04	Rating **	A/W	Issue No.	5
LM End	2.04	Issue Type +	Ma	Location *	WS
Category	Earthen Levee			GPS Latitude/Longitude	
				Start	End
Item	Erosion / Bank Caving			38.589906 °	38.589906 °
				-121.722218 °	-121.722218 °
DWR ID	DWR_ST0012_02_s_2012_5				
Comment Code					
E1 : Note and monitor erosion site.					
Inspector Comment

View of the erosion on the edge of the channel on the waterward side of the levee looking downstream. Fall 2015.

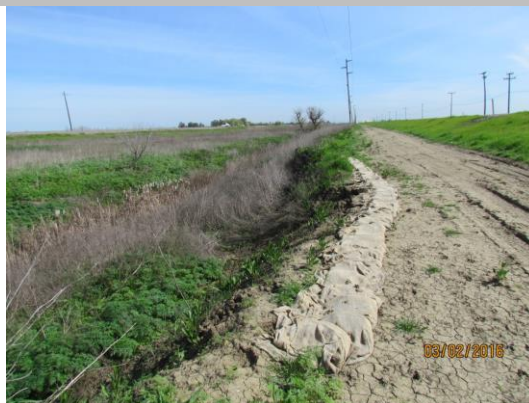
Photo 2 of 2 : SP_2017_ST0012_296_5_20170320_00004.jpg

View of the erosion on the edge of the channel on the waterward side of the levee looking downstream. Spring 2016.

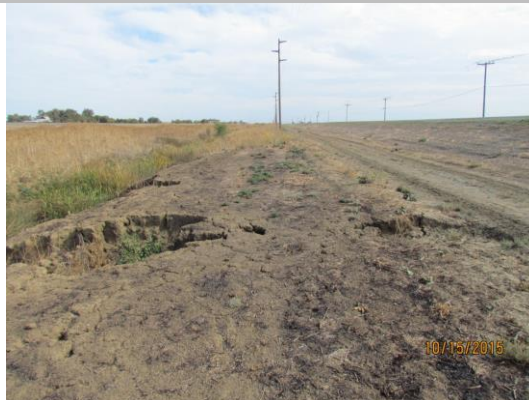
Photo 1 of 2 : SP_2017_ST0012_296_19_20170320_00023.jpg

View of the erosion at the edge of the channel on the waterward side of the levee looking downstream. Fall 2015.

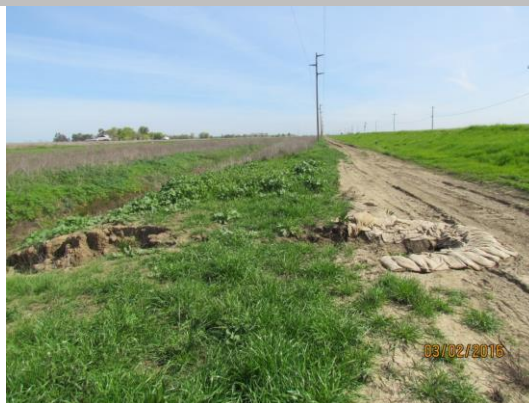
Photo 2 of 2 : SP_2017_ST0012_296_19_20170320_00024.jpg

View of the erosion at the edge of the channel on the waterward side of the levee looking downstream. Spring 2016.

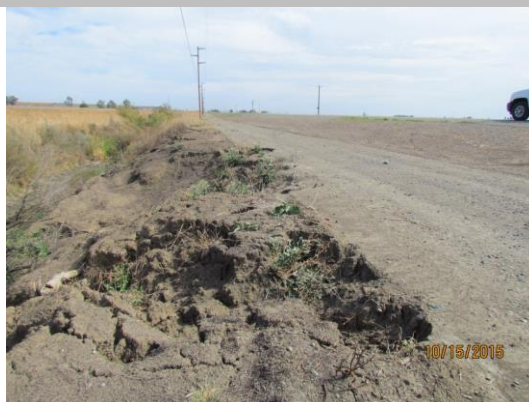
Photo 1 of 1 : SP_2017_ST0012_296_20_20170320_00025.jpg

View of the erosion at the edge of the channel looking downstream. Fall 2015.

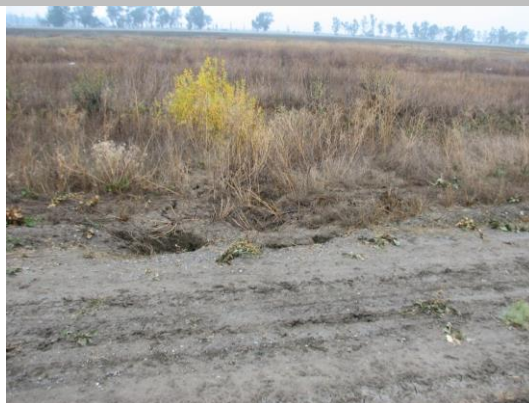
Photo 1 of 2 : SP_2017_ST0012_296_10_20170320_00011.jpg

Erosion on toe road. Fall 2014.

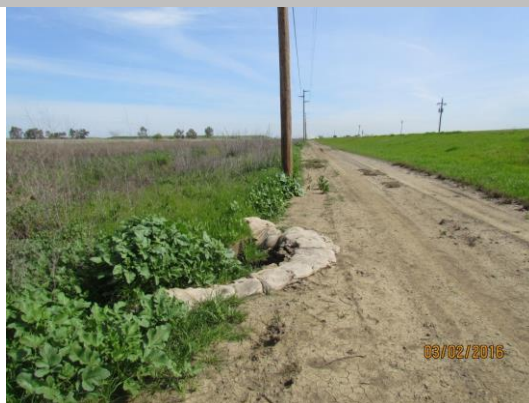
Photo 2 of 2 : SP_2017_ST0012_296_10_20170320_00012.jpg

View of the erosion on the toe road looking downstream. Spring 2016.

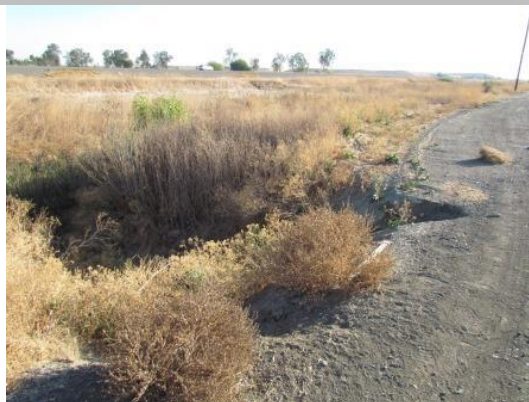
Photo 1 of 3 : SP_2017_ST0012_296_9_20170320_00008.jpg

LM Start	2.97	Rating **	M	Issue No.	9
LM End	2.97	Issue Type +	Ma	Location *	WS
Category	Earthen Levee			GPS Latitude/Longitude	
				Start	End
Item	Erosion / Bank Caving			38.589686 °	38.589686 °
				-121.705041 °	-121.705041 °
DWR ID	DWR_ST0012_02_f_2014_9				
Comment Code					
E2 : Schedule repair of erosion site prior to the next inspection.					
Inspector Comment

An updated view of erosion site on waterward side of the levee that keeps on growing. Fall 2016.

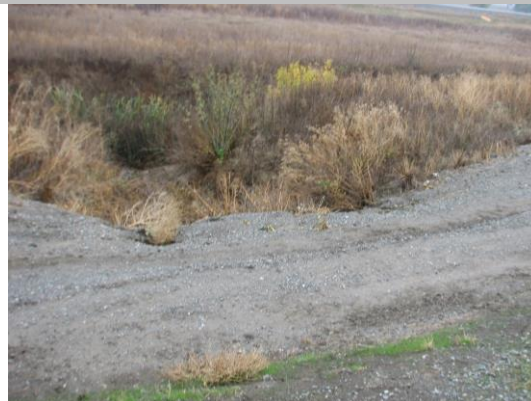
Photo 2 of 3 : SP_2017_ST0012_296_9_20170320_00009.jpg

LM Start	2.97	Rating **	M	Issue No.	9 (cont)	
LM End	2.97	Issue Type +	Ma	Location *	WS	
Category	Earthen Levee			GPS Latitude/Longitude		
				Start		End
Item	Erosion / Bank Caving			38.589686 °	38.589686 °	
				-121.705041 °	-121.705041 °	
DWR ID	DWR_ST0012_02_f_2014_9					
Comment Code						
E2 : Schedule repair of erosion site prior to the next inspection.						
Inspector Comment

Erosion on toe road. Fall 2014.

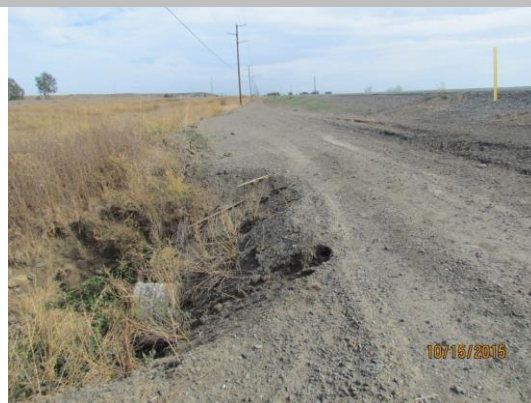
Photo 3 of 3 : SP_2017_ST0012_296_9_20170320_00010.jpg

View of the erosion on the waterward side of the levee looking downstream. Fall 2015.

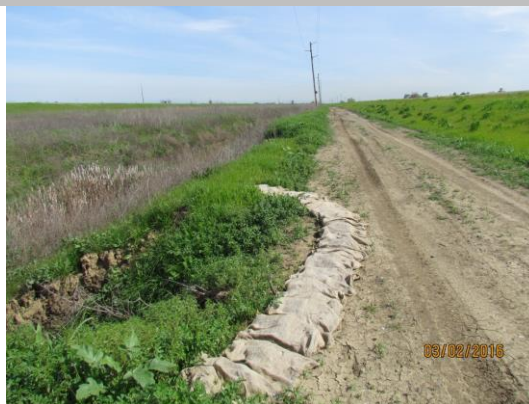
Photo 1 of 1 : SP_2017_ST0012_296_18_20170320_00022.jpg

View of the erosion on the waterward side looking downstream. Spring 2016.

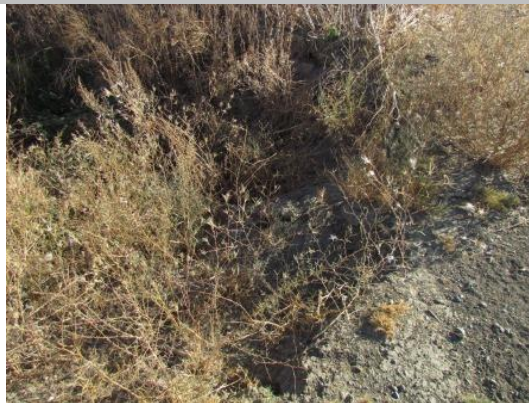
Photo 1 of 3 : SP_2017_ST0012_296_11_20170320_00013.jpg

LM Start	4.29	Rating **	M	Issue No.	11
LM End	4.29	Issue Type +	Ma	Location *	WS
Category	Earthen Levee			GPS Latitude/Longitude	
				Start	End
Item	Erosion / Bank Caving			38.589550 °	38.589550 °
				-121.680632 °	-121.680632 °
DWR ID	DWR_ST0012_02_f_2014_11				
Comment Code					
E2 : Schedule repair of erosion site prior to the next inspection.					
Inspector Comment

An updated view of the erosion site that keeps on growing toward WS levee slope. Fall 2016.

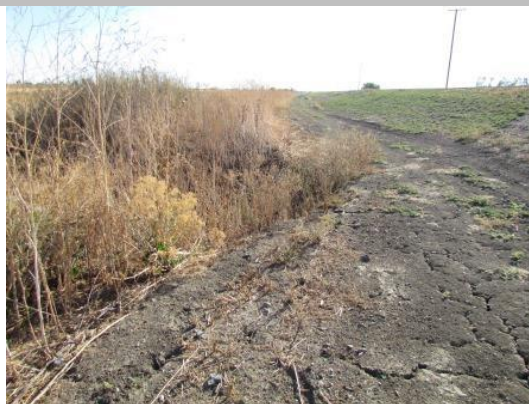
Photo 2 of 3 : SP_2017_ST0012_296_11_20170320_00014.jpg

Perspective view of the site. Fall 2016.

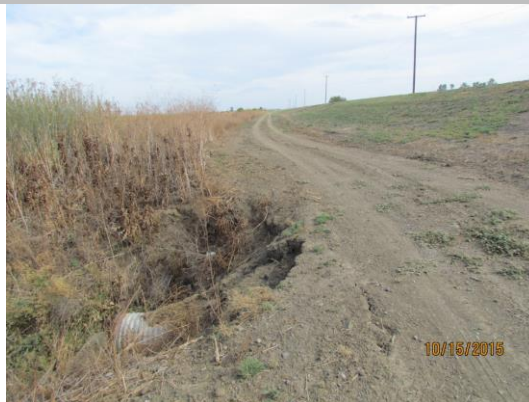
Photo 3 of 3 : SP_2017_ST0012_296_11_20170320_00015.jpg

View of the erosion at the edge of the channel on the waterward side of the levee looking downstream. Fall 2015.

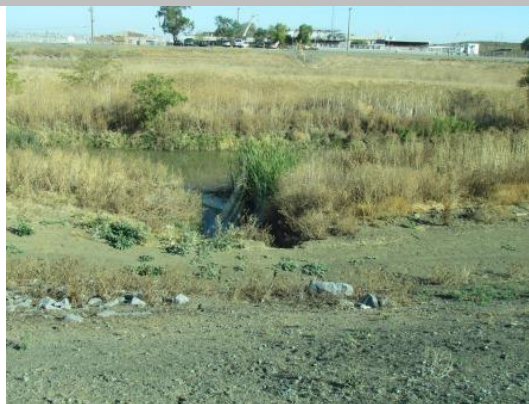
Photo 1 of 3 : SP_2017_ST0012_296_15_20170320_00017.jpg

LM Start	5.05	Rating **	M	Issue No.	15
LM End	5.05	Issue Type +	Ma	Location *	WS
Category	Earthen Levee			GPS Latitude/Longitude	
				Start	End
Item	Erosion / Bank Caving			38.589570 °	38.589570 °
				-121.666588 °	-121.666588 °
DWR ID	DWR_ST0012_02_s_2015_15				
Comment Code					
E2 : Schedule repair of erosion site prior to the next inspection.					
Inspector Comment

An updated view of the erosion site that keeps on growing toward WS levee slope. Fall 2016.

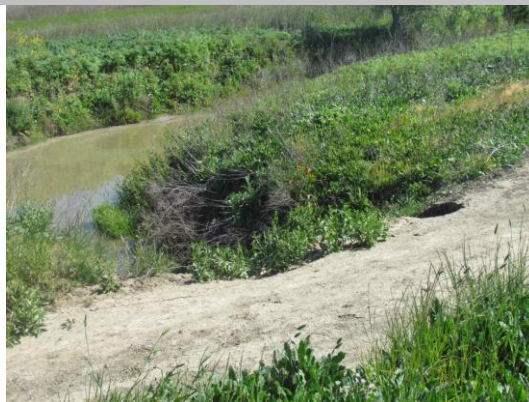
Photo 2 of 3 : SP_2017_ST0012_296_15_20170320_00018.jpg

View of the erosion on the edge of the channel on the waterward side of the levee. Spring 2015.

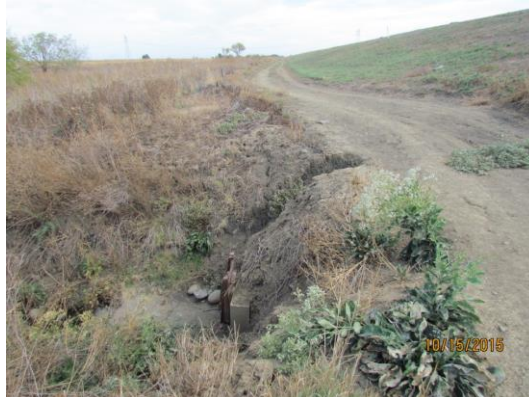
Photo 3 of 3 : SP_2017_ST0012_296_15_20170320_00019.jpg

LM Start	5.05	Rating **	M	Issue No.	15 (cont)	
LM End	5.05	Issue Type +	Ma	Location *	WS	
Category	Earthen Levee			GPS Latitude/Longitude		
				Start		End
Item	Erosion / Bank Caving			38.589570 °		38.589570 °
				-121.666588 °		-121.666588 °
DWR ID	DWR_ST0012_02_s_2015_15					
Comment Code						
E2 : Schedule repair of erosion site prior to the next inspection.						
Inspector Comment

View of the erosion at the edge of the channel on the waterward side of the levee looking downstream. Fall 2015.

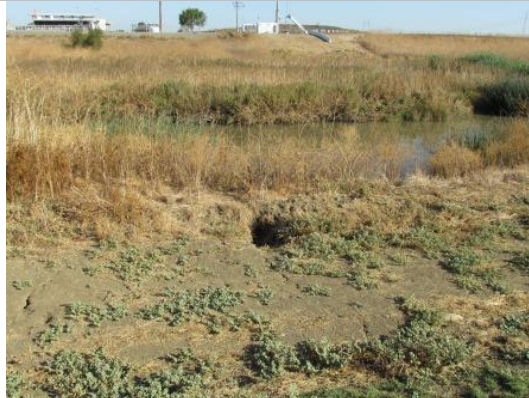
Photo 1 of 1 : SP_2017_ST0012_296_17_20170320_00021.jpg

View of a site that may become a larger erosion site in the future. Waterward side of the levee looking downstream. Fall 2016.

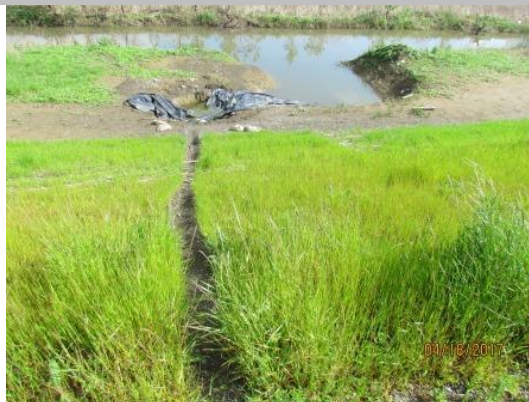
Photo 1 of 1 : SP_2017_ST0012_296_32_20170419_00041.jpg

LM Start	5.59	Rating **	M	Issue No.	32
LM End	5.59	Issue Type +	Ma	Location *	WS
Category	Earthen Levee			GPS Latitude/Longitude	
				Start	End
Item	Erosion / Bank Caving			38.589532 °	38.589532 °
				-121.656631 °	-121.656631 °
DWR ID	DWR_ST0012_02_s_2017_32				
Comment Code					
E2 : Schedule repair of erosion site prior to the next inspection.					
Inspector Comment

View of erosion on waterside levee slope. Spring 2017.

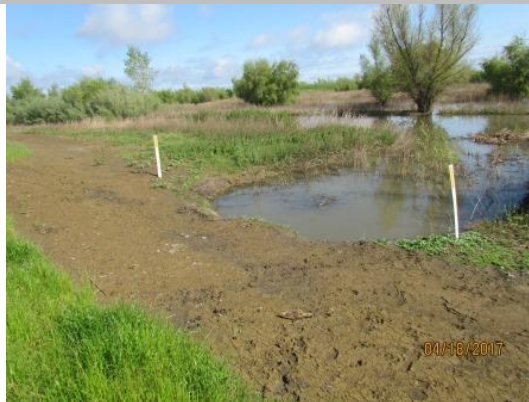
Photo 1 of 1 : SP_2017_ST0012_296_33_20170419_00042.jpg

View of erosion into waterside levee prism. Spring 2017.

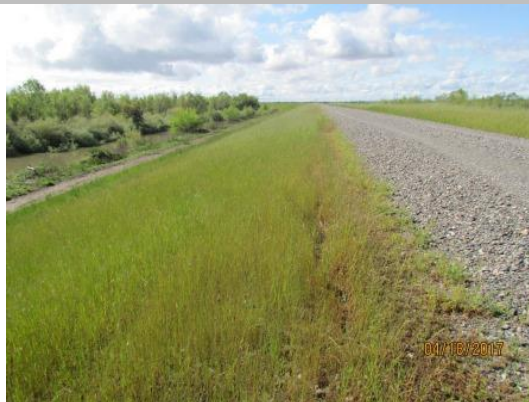
Photo 1 of 1 : SP_2017_ST0012_296_34_20170419_00043.jpg

Tall vegetation on waterside levee slope, blocking visibility. Spring 2017.

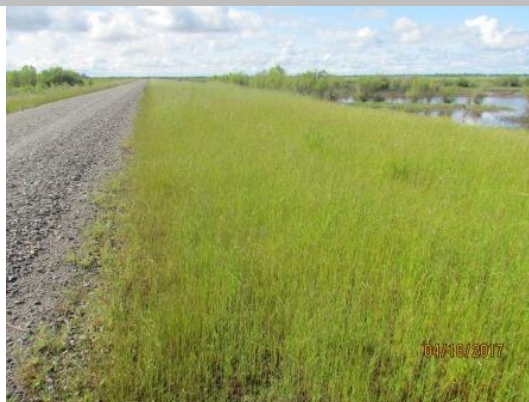
Photo 1 of 1 : SP_2017_ST0012_296_35_20170419_00044.jpg

Tall grass on landside levee slope, blocking visibility. Spring 2017.

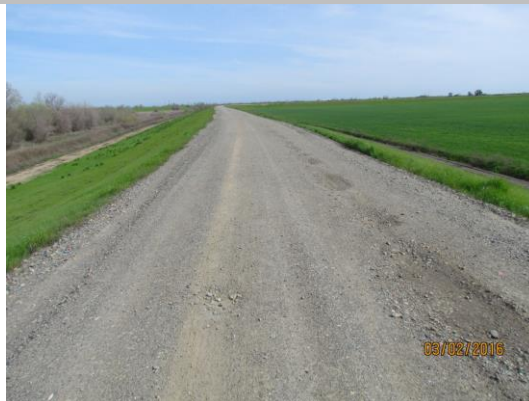
Photo 1 of 1 : SP_2017_ST0012_296_25_20170320_00032.jpg

View of the crown of the levee looking downstream. Road needs to be regraded. Spring 2016.
